## RIVER RESTORATION WORKS AT GROGLEY GAUGING STATION

The river restoration works at Grogley Gauging Station on the main river Camel are now complete.

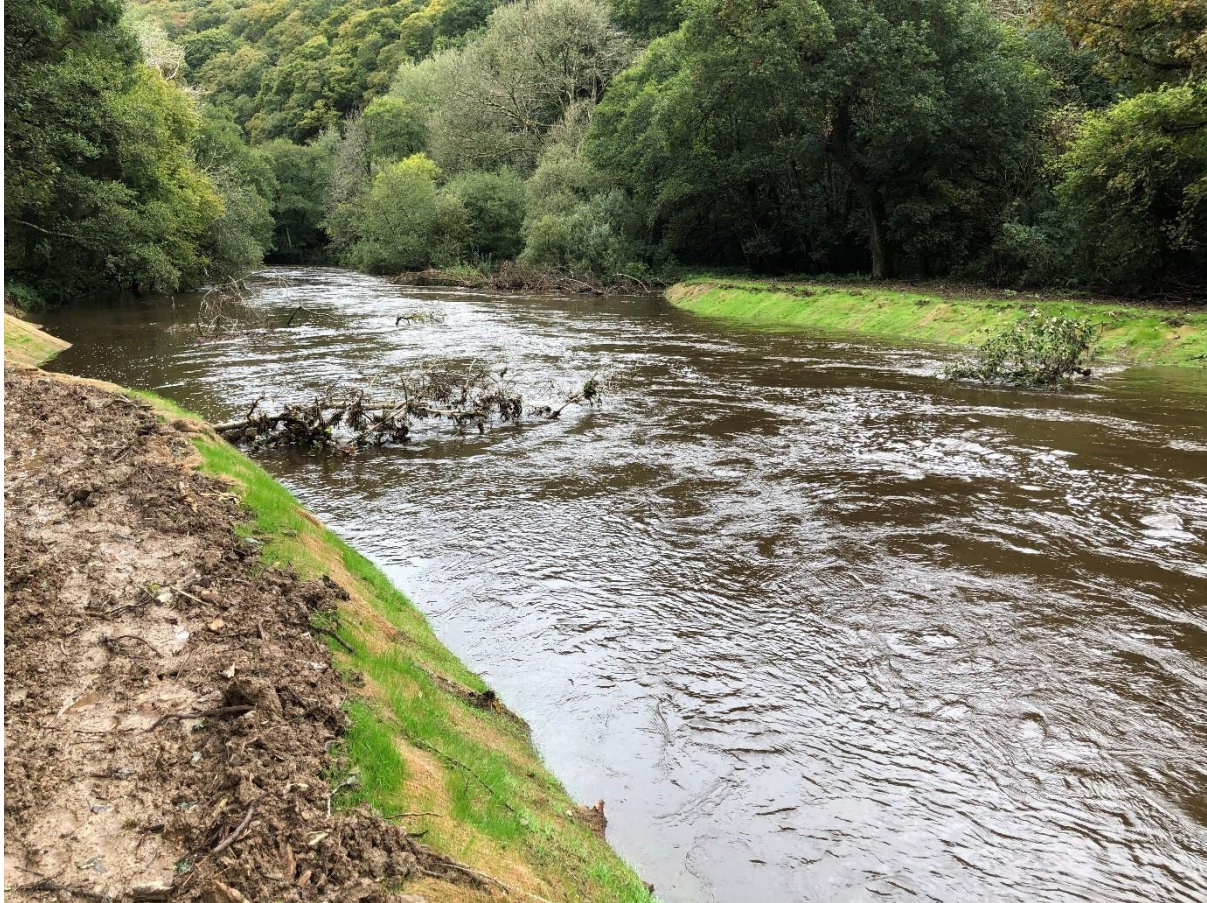
The work involved the removal of the concrete weir, sheet piling and gabion baskets, with approximately 60-65m of block stone removed along both banks.

The new banks were battered back, seeded and Bionet installed to reduce the potential for erosion while the reach stabilises through vegetation establishment. In addition, a series of wood deflectors were added to improve flow and habitat diversity and provide cover for fish.

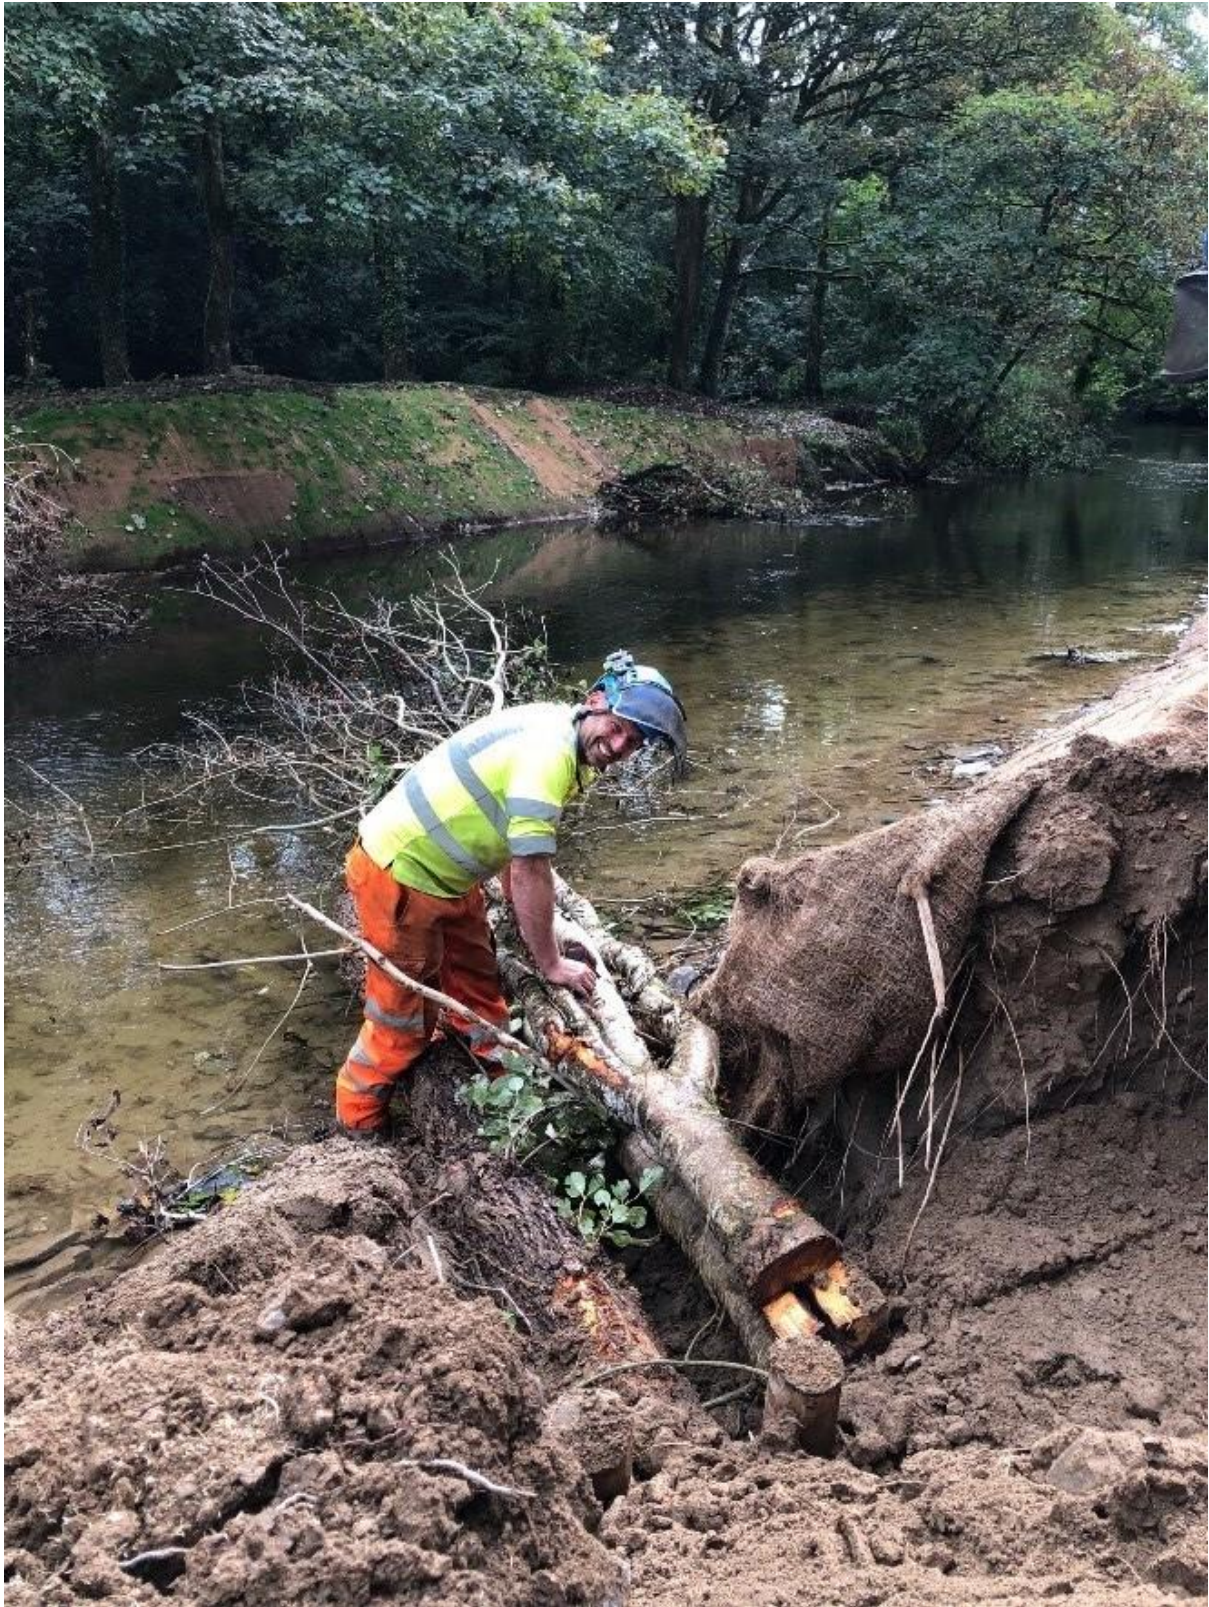
The access track, built to allow access to the river, has been removed and the hedge has been rebuilt.
